## Church Road Footpath Safety Improvements

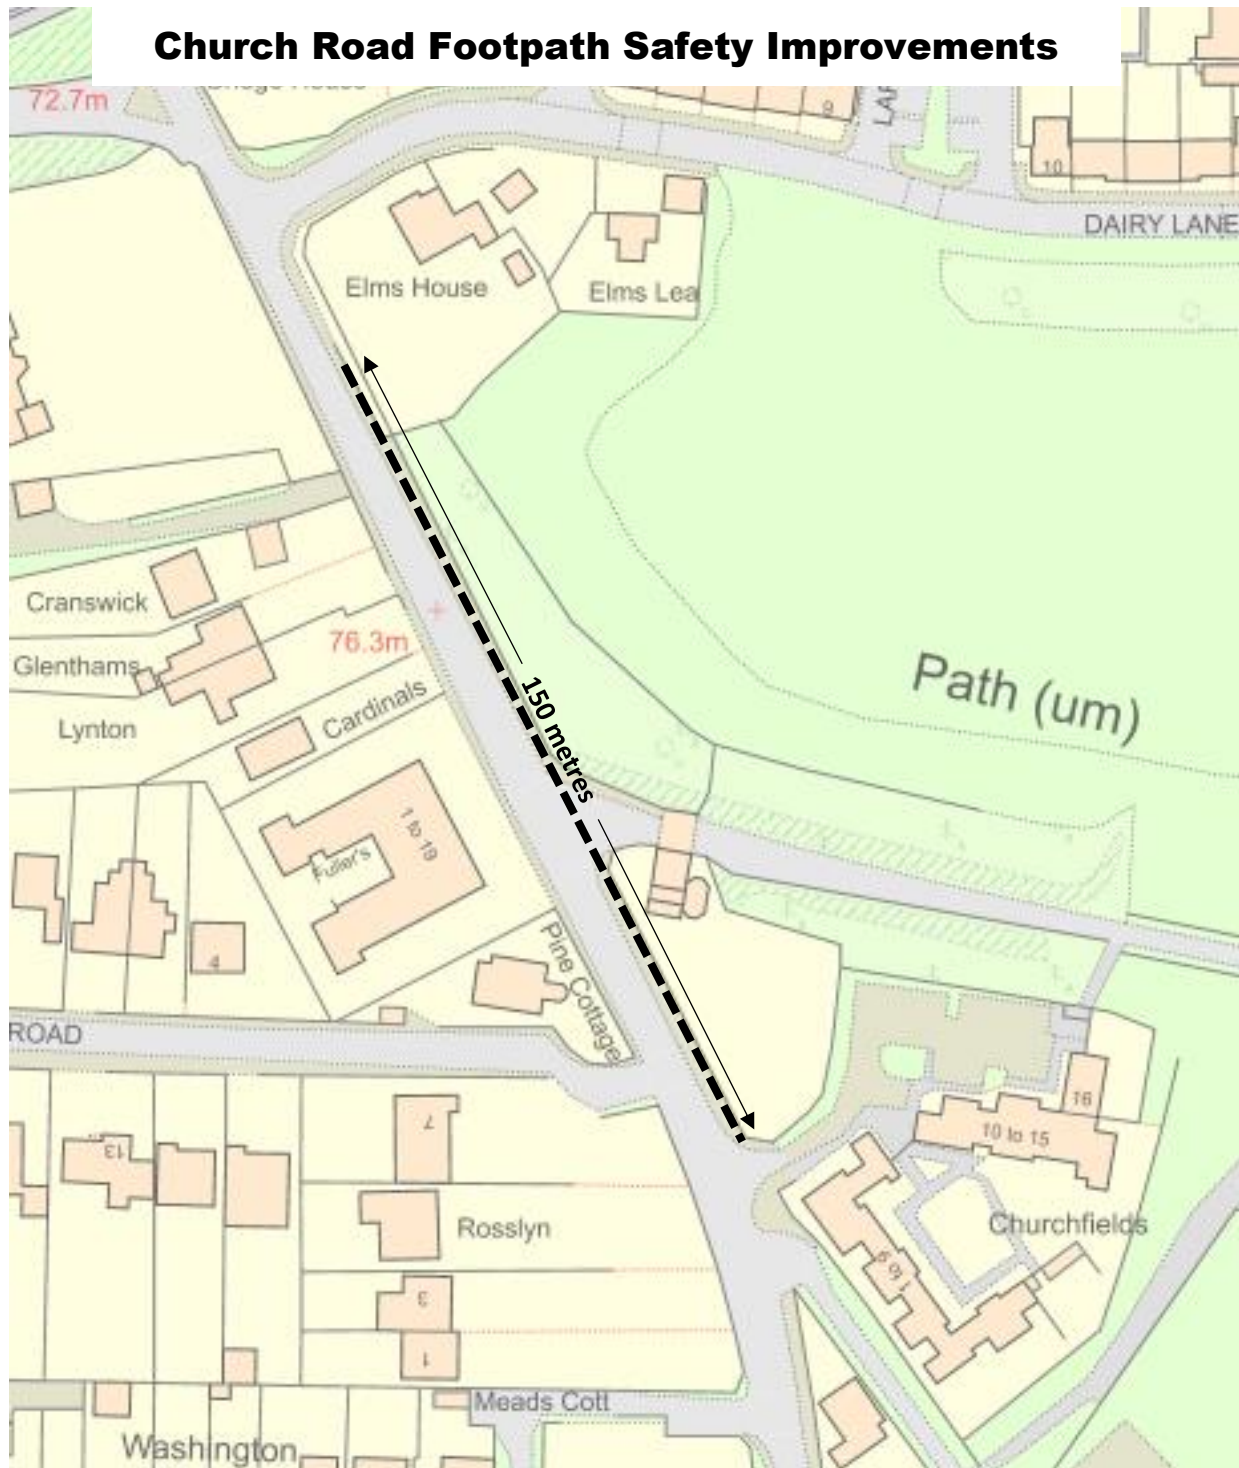
The dashed line shown in the above picture indicates a length of approximately 150 metres, measured from the second streetlight, south of Dairy Lane, up to the entrance to Churchfields. This stretch of footpath has become a hazardous experience for residents as it has been narrowed by growth of vegetation leaving no room for pedestrians to walk safely to pass in opposite directions. There have been instances where pedestrians have been hit by the door mirrors of lorries avoiding potential collisions with oncoming traffic.

The need to improve pedestrian safety is a high priority. The necessary works will include cutting back the vegetation to the line set by the original concrete post and wire fencing and resurfacing of the path as required.

It is proposed that new post and wire fencing is installed with concrete gravel boards to prevent further encroachment. The moving of the streetlights and road signposts back to the boundary line will allow sufficient increase in footpath width to offer safe passage and room for double buggies to pass one another.
